Ti 6Al – 4V – Alpha Case – 200x

Ti 6Al – 4V – Fold with Alpha Case – 500x

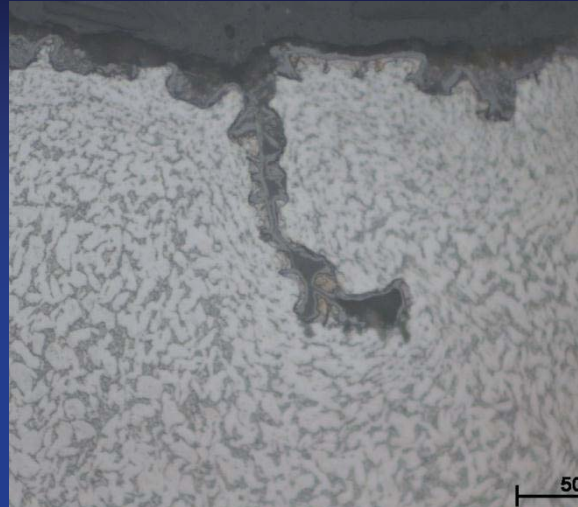
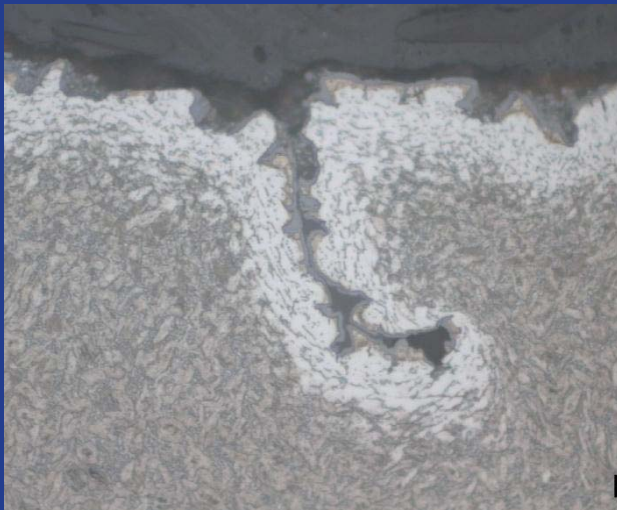
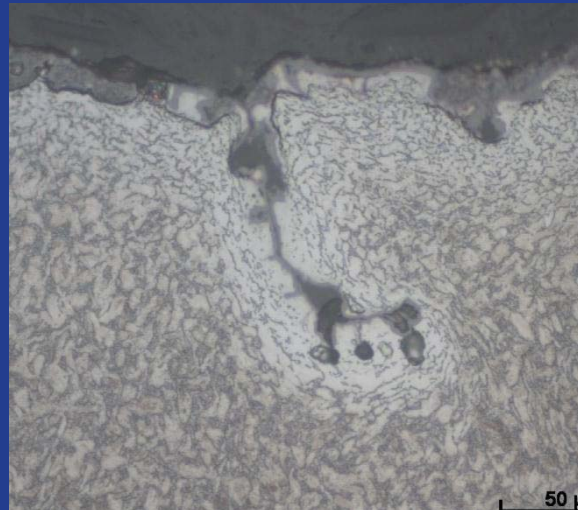
Kroll's

Ti

Boeing

2% HF

Oxalic

Ti & Oxalic

- Effect with 2% HF, Boeing , Oxalic & Ti + oxalic are similar
- Base microstructure has influence on results
- Oxalic acid etchant can be used after etching with Kroll's or Ti etch without loss of information

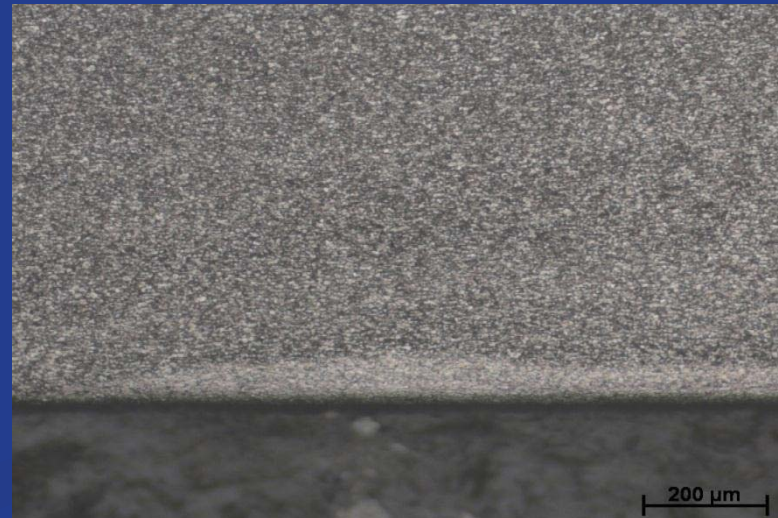
Grinding Burn on Bearing Surface – 100x

Kroll's

Oxalic

- Visual Examination:
 - Oxalic acid etchant is the best to detect grinding burns on the bearing surface

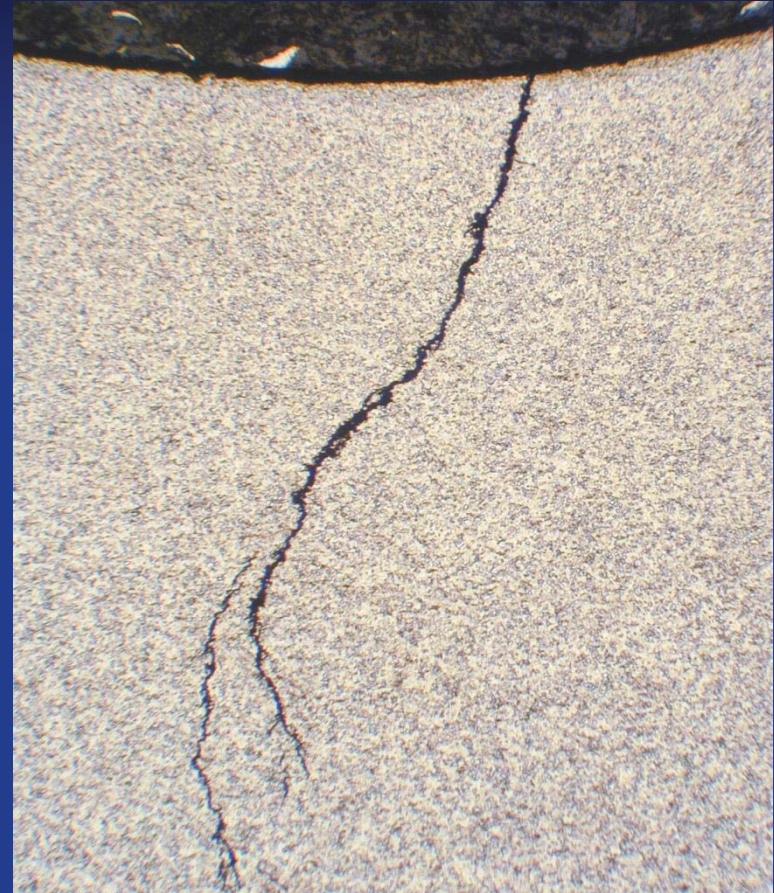
Liquid Metal Embrittlement

- Sectioning of Cd plated titanium can cause cracks in unusual locations

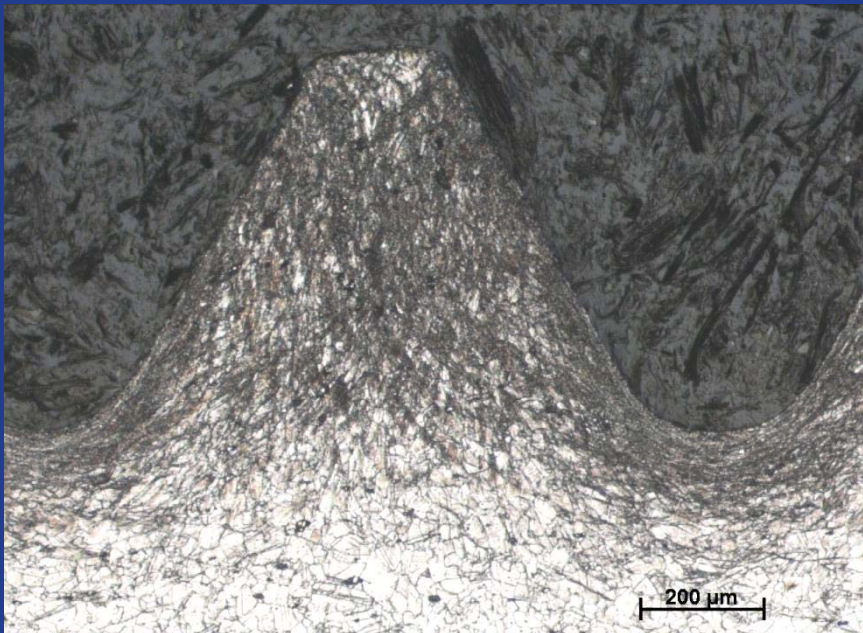
Etching too dark, laps would be difficult to detect
